Case Study: Remeandering and the Garrel Burn

Location: Kilsyth, North Lanarkshire

Restoration: 600 m of re-meandering plus, two 'pre weir' fish ladders

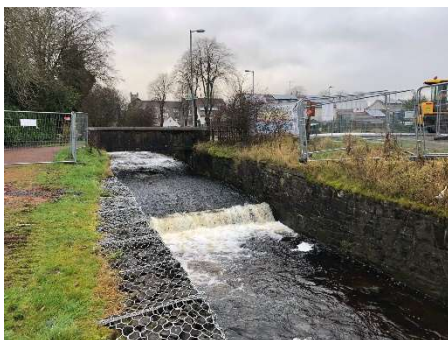
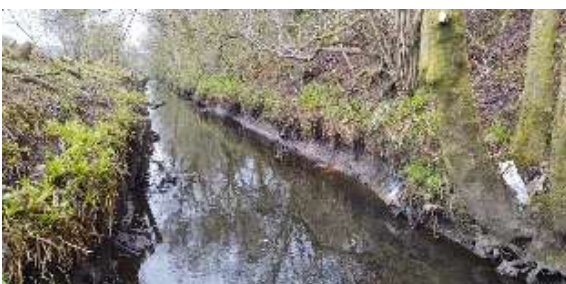
Pre-restoration condition of the Garrel Burn

Historical mapping shows the Garrel Burn was realigned and straightened over 250 years ago during either 17th or 18th century creating an incised, simplified channel which was disconnected from its floodplain and lacking in morphological and habitat diversity. This was further enhanced by frequent dredging and embankment construction. Further to this, two weirs located within the river at Kilsyth prevented access to over 1.5 km of quality habitat to migrating fish (eel, trout, salmon, lamprey).

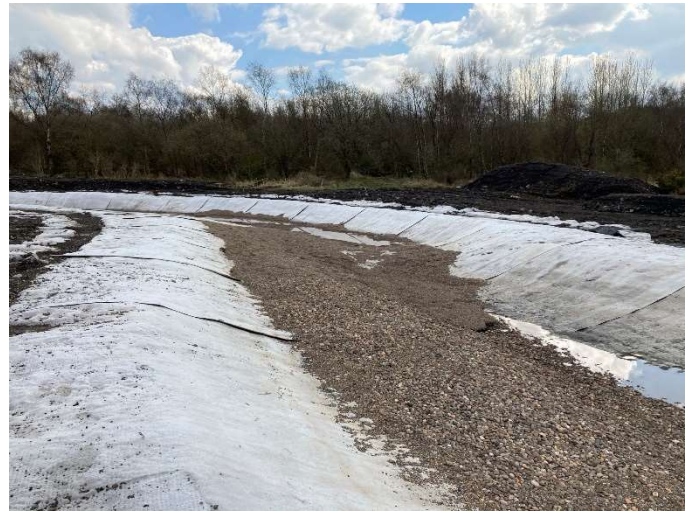
Upper reach of restored channel during construction showing clay liner.

Land contamination and below ground utilities meant the upper 200 m of the new channel had to be fixed and was covered with a geosynthetic clay liner. To ensure the liner was effectively 'activated' (i.e., covered with 300 mm of fill) and protected from erosion, the topsoil that makes up the banks was placed on the liner and covered with a biodegradable geotextile and the lower 1/3 of the banks covered with quarried stone on.

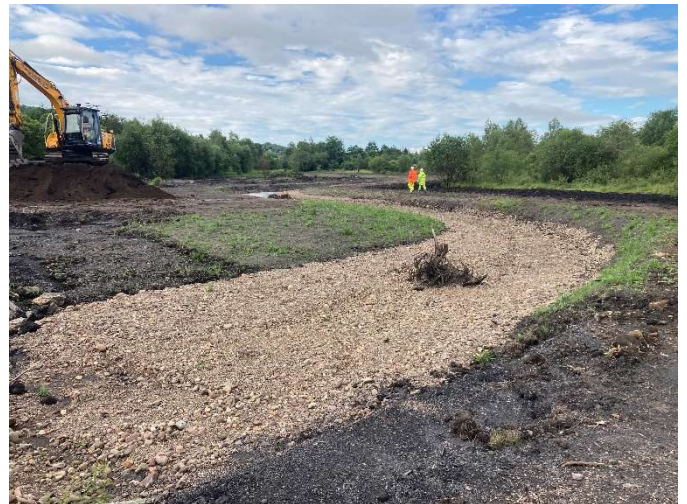
Lower reach of restored channel showing bar apex large wood structure during construction.

In the lower reach all constraints to lateral adjustment have been removed to allow the channel to adjust naturally to its restored flow and sediment transport regime. Large wood structures were added to provide a catalyst for natural channel evolution, especially greater pool and gravel bar development. The channel banks along this section were also lined with a biodegradable geotextile to protect them from erosion while vegetation established.

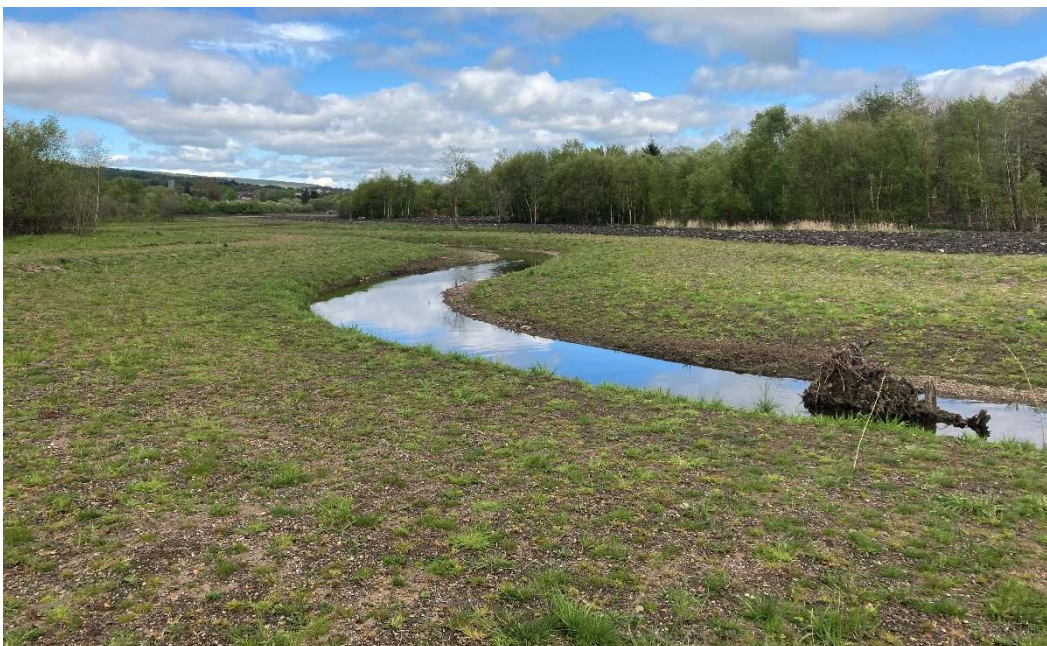
Restored Garrel Burn channel in April 2022.

Post restoration the habitat complexity of the site has improved through the creation greater diversity of geomorphic units and bed complexity (even in the upper reach where lateral adjustment is restricted). The large wood structures not only assisted in increasing morphological complexity but also provides good habitat for trout.

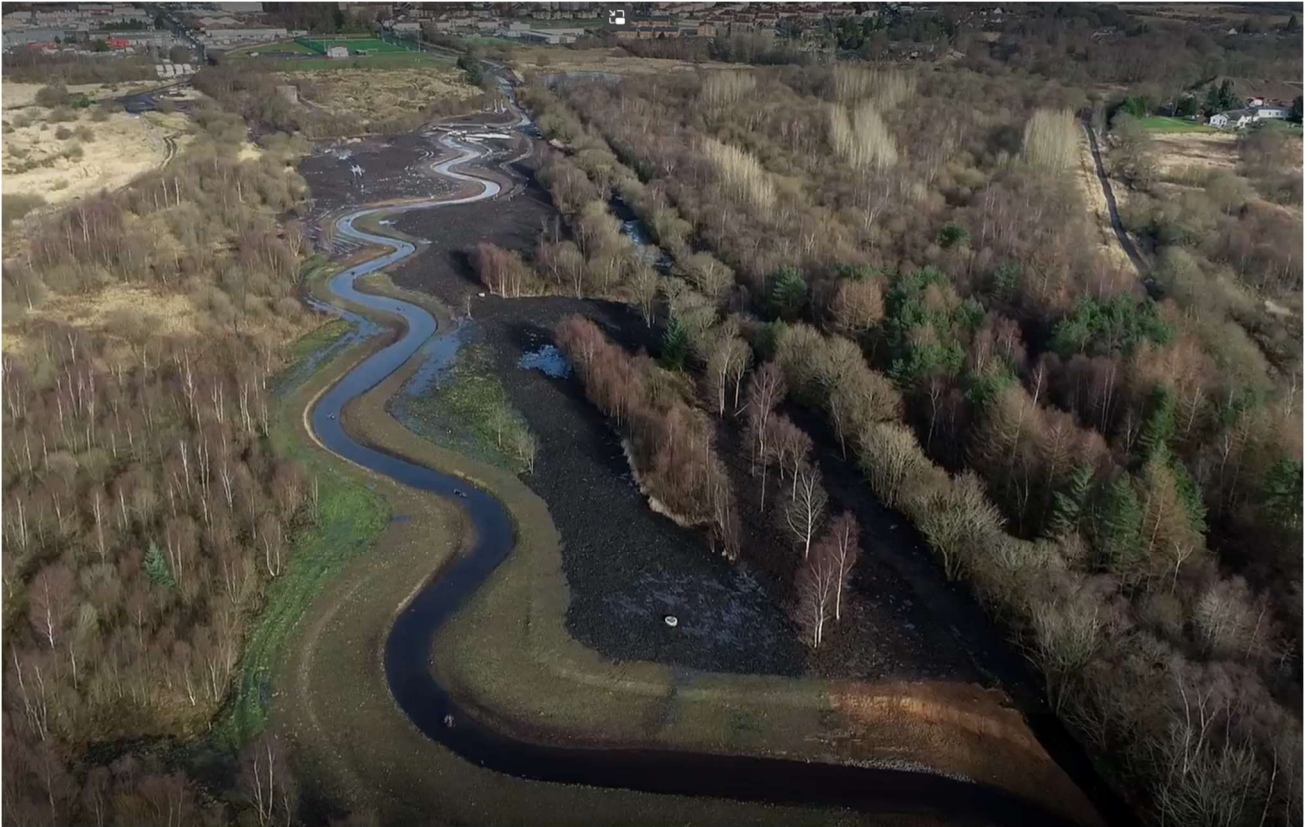
Drone footage of the Garrel Burn in March 2022, immediately after construction was complete.

A new 600 m meandering course with alluvial bars, riffles and pools was constructed within Dumbreck Marsh. Large wood structures were placed in the channel at the apex of the meander bends to increase flow diversity and kick-start morphological evolution i.e., encourage pool and alluvial bar development. The restored channel is connected to its floodplain, restoring a more natural flood regime and that will encourage the reinstatement of the marshy floodplain.

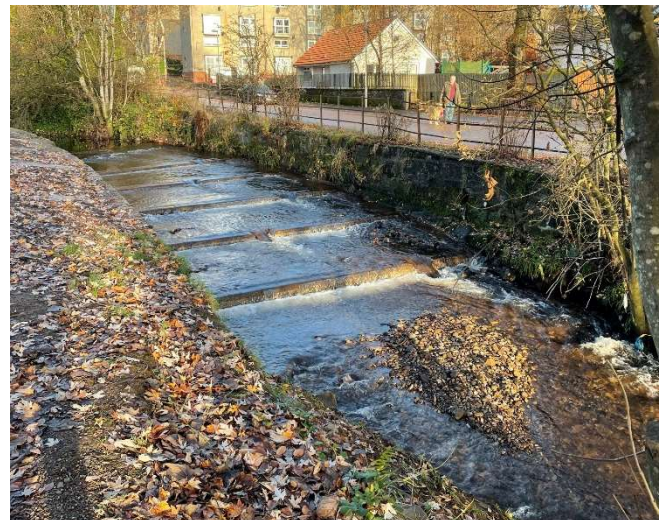
Completed pre weir to improve fish passage in November 2021.

The project also included the construction of two "pre-weir" fish ladders below the weirs within Kilsyth town to improve fish passage.

The potential for fish to migrate upstream has been significantly improved through the construction of the two pre-weir fish ladders downstream of the two historic concrete weirs.
